FINAL REPORT

**A FUNDAMENTAL APPROACH TO ADHESION:
SYNTHESIS, SURFACE ANALYSIS,
THERMODYNAMICS AND MECHANICS**

Wen Chen and James P. Wightman

National Aeronautics and Space Administration

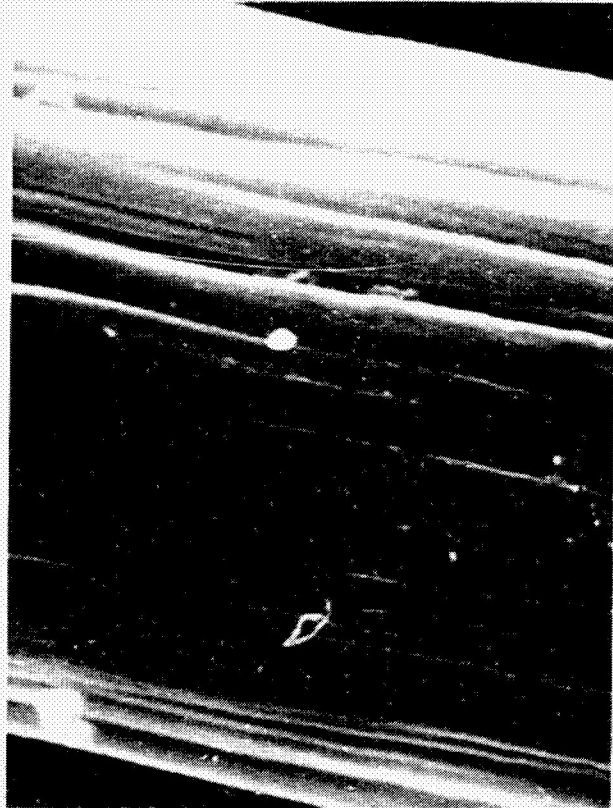
Figure 2.

SEM photomicrographs (2,000x, 10,000x) of
HTS-2 graphite fiber (Batch #94-3).

SEM photomicrographs of seven graphite fibers are shown in Figures 1-7. The HMS fiber (Fig. 1) is characterized by surface striations whereas the HTS-2 fiber (Fig. 2) appears smooth. The other fibers were coated as noted in Table III. The epoxy coated Thornel fiber (Fig. 3) clearly shows striations. Although the Celion 600 fibers are coated (Fig. 4), surface striations are apparent both before and after solvent washing. The striations may be somewhat more marked after washing. The SEM of the styrene-maleic anhydride graphite fiber (Fig. 5) has a patchy appearance not noticed for the other fibers. Again, striations are apparent in the CG-3 fibers (Fig. 6) before and after solvent rinse. Coated HT-S fibers in Fig. 7 are quite different to the uncoated fibers shown in Fig. 2.

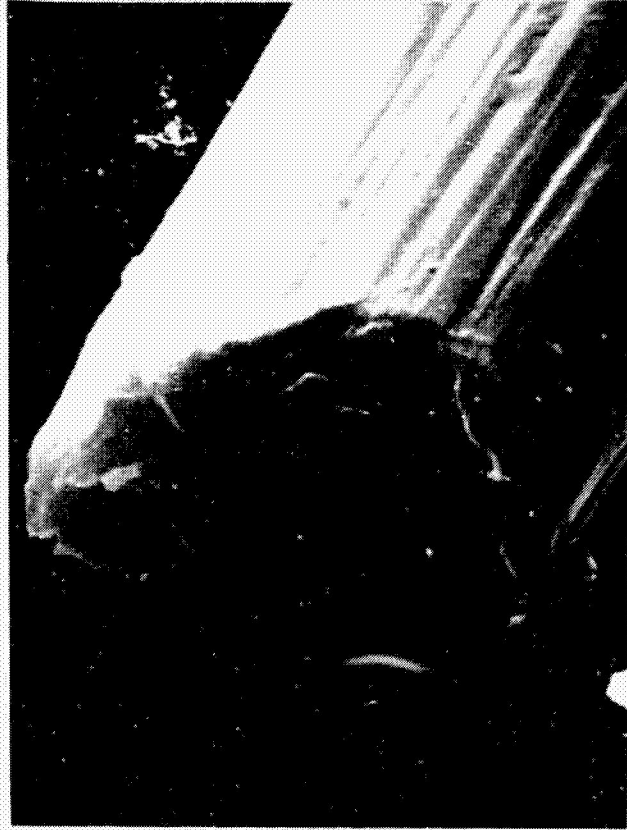
Figure 4.

SEM photomicrographs (2,000x, 10,000x) of Celion 6000
graphite fiber (Lot #HTA-7-7711).

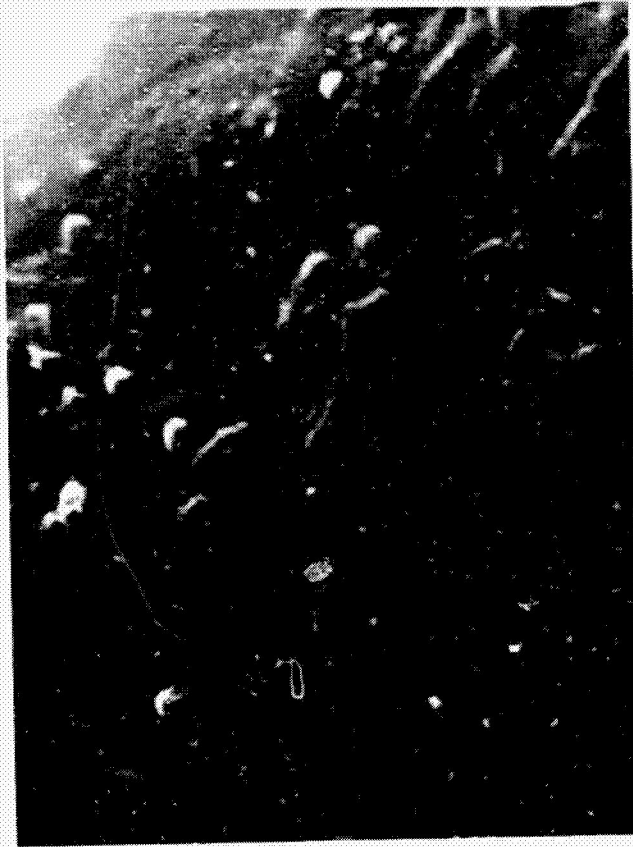
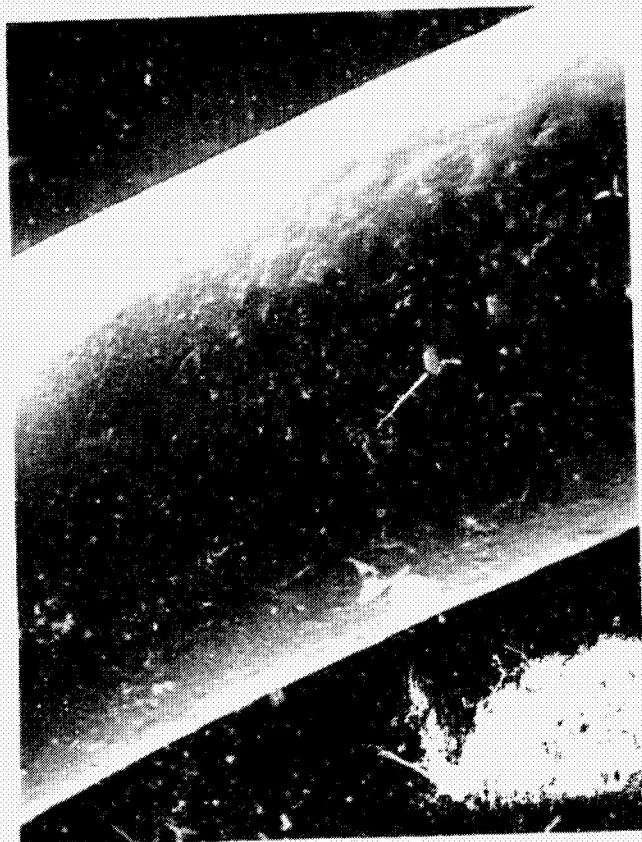
FIGURE 6.

SEM photomicrographs (2,000x, 5,000x) of
NASA-2 graphite fiber.

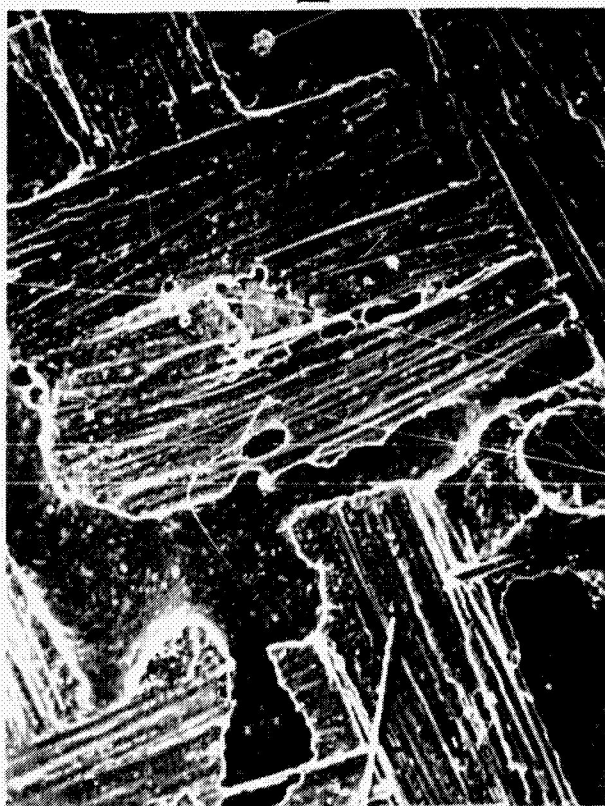
- Figure 27. SEM photomicrographs of fracture surfaces of Ti 6-4 bonded with LaRC-13 containing 15% fluorosiloxane elastomer.
- A. SEM photomicrographs (100x, 1000x) of one side of fracture. No Ti 6-4 substrate is noted.
 - B. SEM photomicrographs (500x, 2000x) of opposite side of fracture. Again, no Ti 6-4 substrate is noted; coated scrim cloth seen on both faces.

2. LaRC-13/elastomer.--SEM photomicrographs of opposing sides of a bonded adhesive joint after fracture in a T-peel test are shown in Figure 27. The LaRC-13 adhesive in this case contained 15% of a fluorosiloxane elastomer. The fractography is totally different than that noted when no elastomer was present (Fig. 26). No Ti 6-4 substrate is observed on either side. The ESCA results listed in Table VIII support the conclusion that fracture occurred within the adhesive since no Ti signal was observed. In addition, significant increases in the surface concentrations of fluorine and silicon are expected on using a fluorosiloxane polymer.

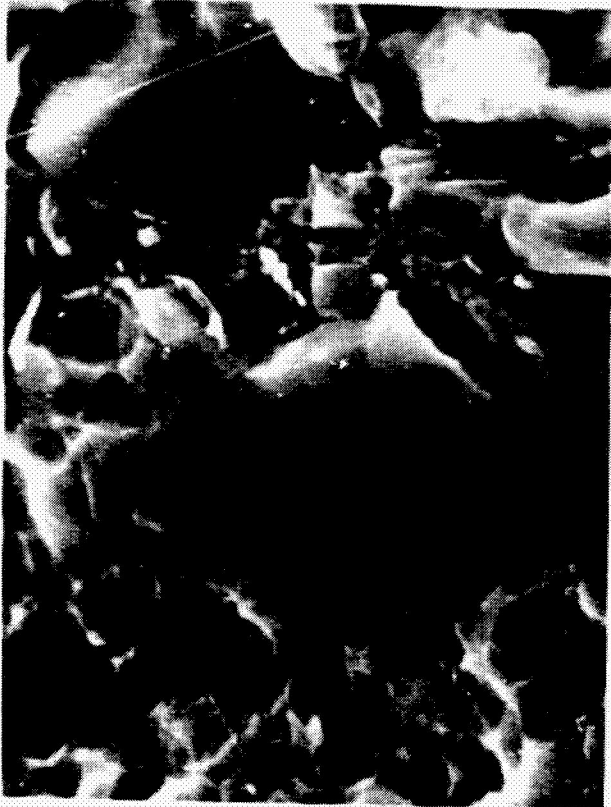
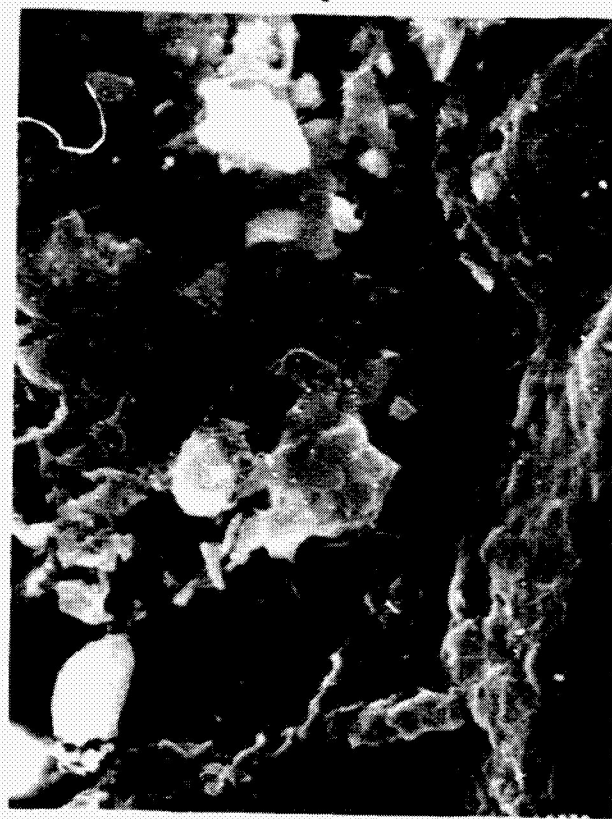
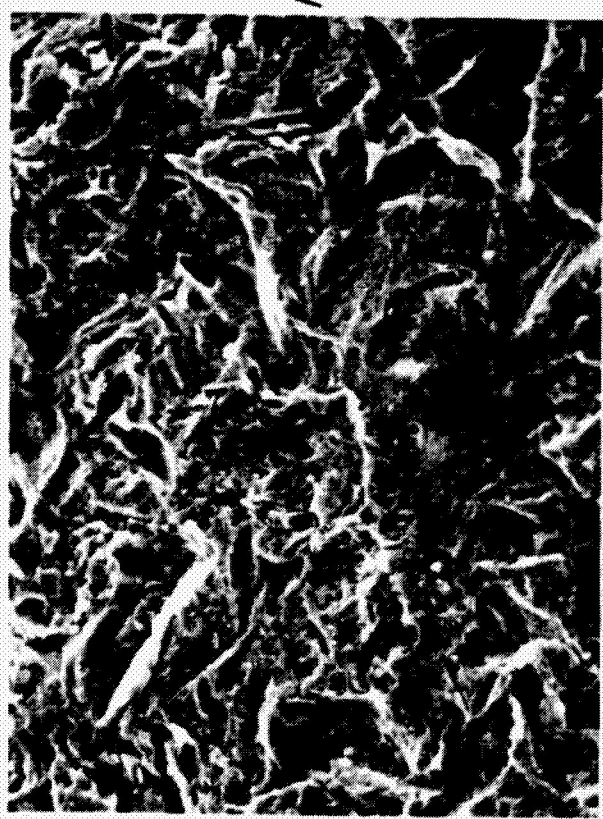
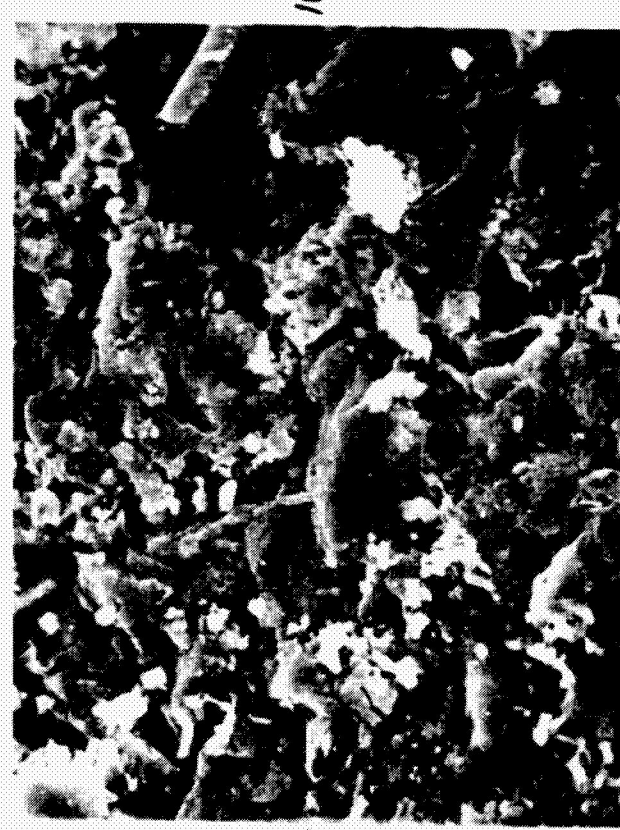
Figure 28. SEM photomicrographs of #1499P-1 fracture surfaces.

Sample #1499P-1 is a specimen after fracture in a lap shear test. T1 6-4 was reportedly given a grit-blast followed by a phosphate/fluoride etch.

- A. SEM photomicrographs (1,000x, 10,000x) of an area of the fracture surface showing the bare metal.
- B. SEM photomicrographs (1,000x, 5,000x) of an area of the 1499P-1 sample fracture surface showing the adhesive on the metal substrate.

the fracture surface are shown in Figure 28. Area A was from a "bare" metal area and area B was from an "adhesive" area. It appears from the photomicrographs that the Ti 6-4 was only grit-blasted but given no phosphate/fluoride treatment. This conclusion is based on a comparison with typical grit-blasted and phosphate/fluoride pretreated samples seen in Figures 2 and 5, respectively, in a previous report (3). A typical Ti 6-4 surface after grit blasting and a phosphate/fluoride etch is also seen in Figure 32B of the present report.

The ESCA results for these two samples are listed in Table VIII. A Ti signal was noted from area A but not from area B. The sample containing area A was cleaned subsequently in an argon discharge (6) for 60 seconds resulting in a lower carbon signal and a concomitant larger titanium signal as noted in Table VIII.

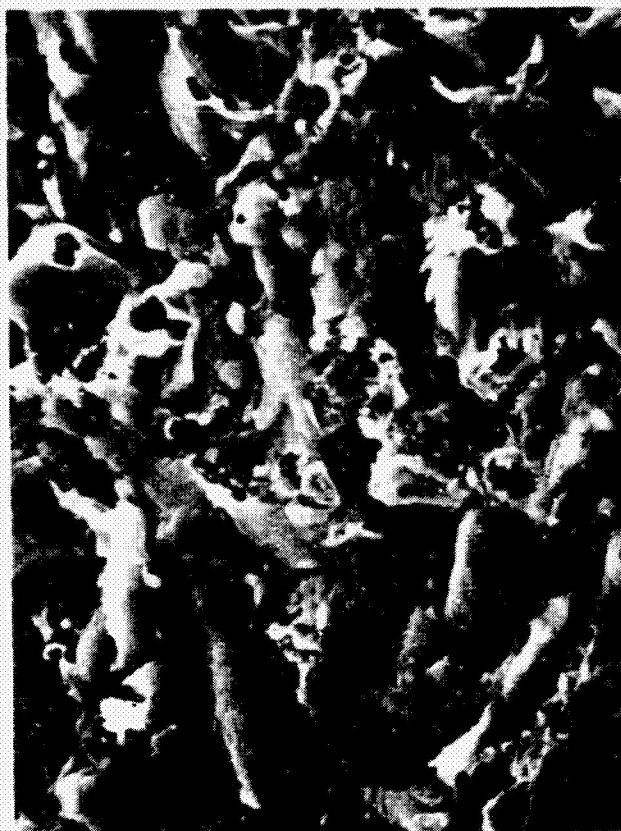
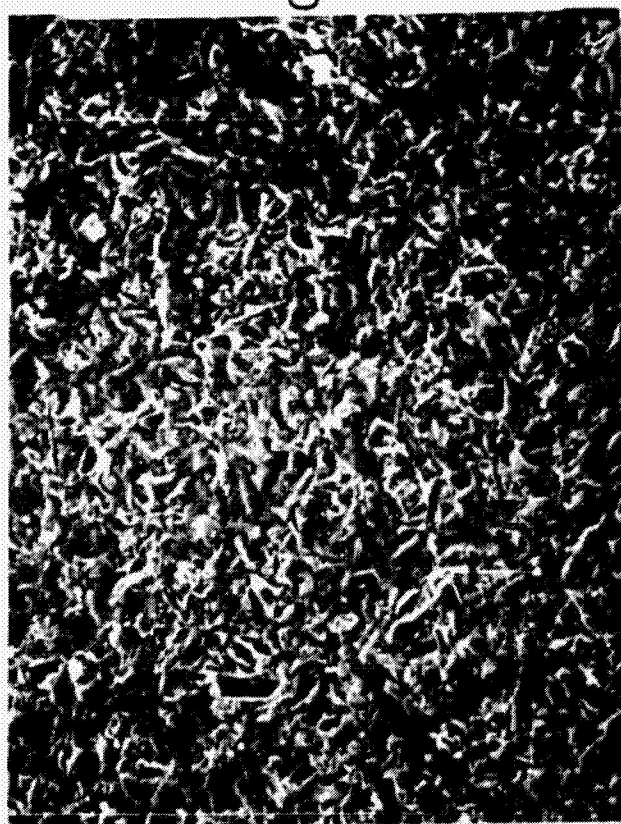
Figure 30.

**SEM photomicrographs of Ti 6-4 substrates
of #813-11-5.**

The SEM photomicrograph of the primed adherend after a chloroform rinse is shown in Figure 30 B. Any residual primer coating is not apparent in this figure. However, the ESCA results in Table IX, where only a weak ($C/Ti = 20.2$) Ti signal was noted, demonstrate the presence of a thin residual primer film.
